ABRADABLE DUAL-DENSITY CERAMIC TURBINE SEAL SYSTEM

FINAL REPORT

**DETROIT DIESEL ALLISON DIVISION
GENERAL MOTORS CORPORATION
INDIANAPOLIS, INDIANA 46206**

**NASA LEWIS RESEARCH CENTER
CONTRACT NAS 3-22012**

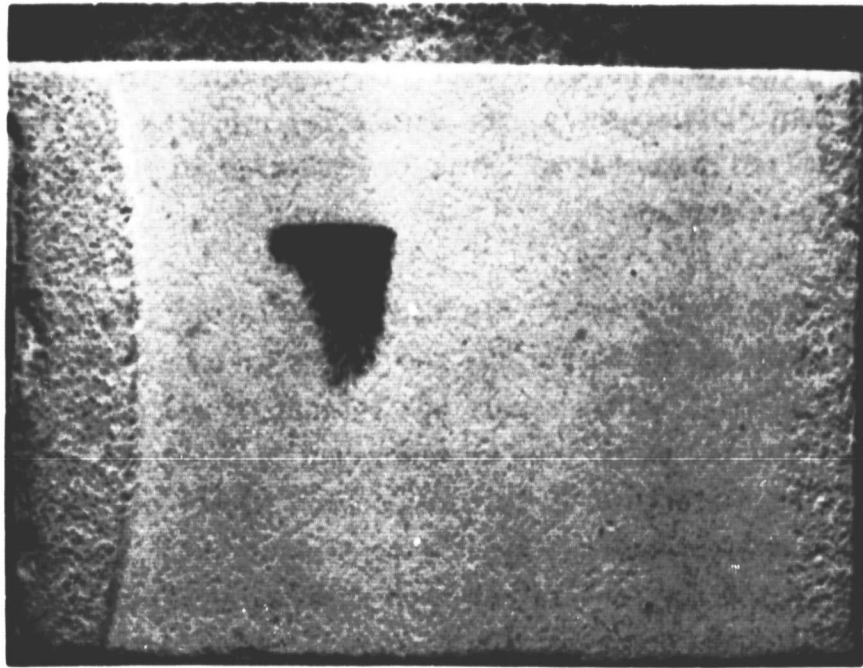
The rub wear scar shown in Figure 7 was obtained in a low speed test of a system comprised of 50 v/o YSZ and 50 v/o pyrophyllite ($\text{Al}_2\text{Si}_4\text{O}_{10}(\text{OH})_2$). This result was typical of all tests in which solid-filled YSZ structures were abraded by turbine wheels of cast MAR-M246 alloy. There are several features common to all of these solid-filled systems. Most pronounced was the tendency of each structure to compact or densify in the rub zone rather than shear as originally anticipated. Accompanying the observed densification were 1) adhesive transfer of blade tip material in varying degrees and 2) nearly total absence of seal structure penetration by the blade tip.

Although the filled structures tested were non-optimized, the rub wear scars produced were significantly more severe than those obtained with non-filled normal density YSZ structures. Since the latter are considered to be virtually "non-abradable", there appeared to be little potential for producing the desired abrasability using the solid filler approach. These efforts were

Figure 7 Abradability Wear Scar 50 v/o YSZ/50 v/o Pyrophyllite

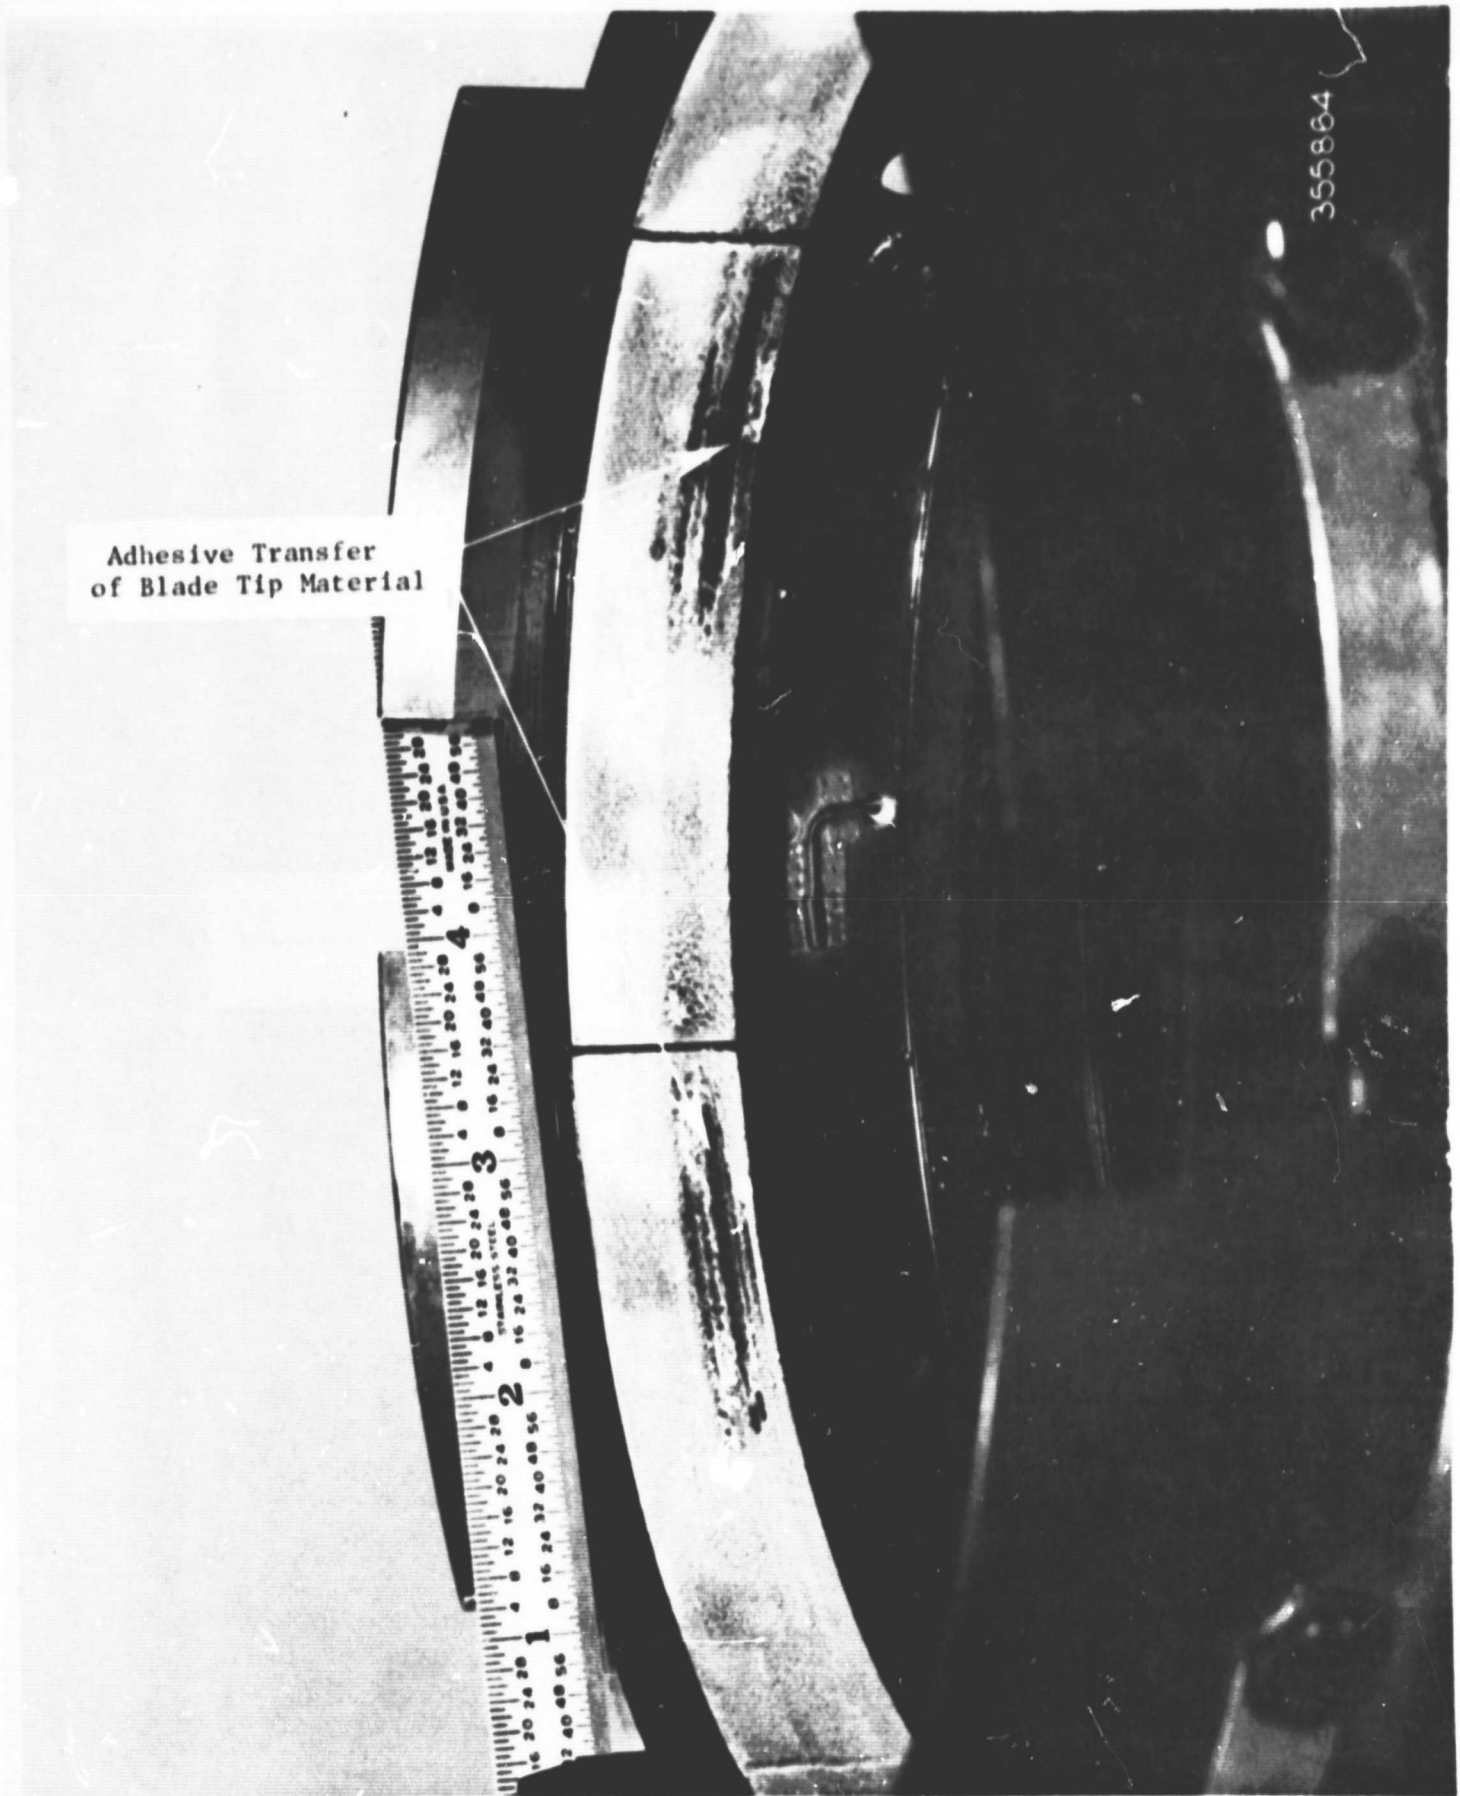
Figure 60 Adhesive transfer to GMA 500/ATDE first-stage turbine tip seal following heavy rub during first minute of operation.

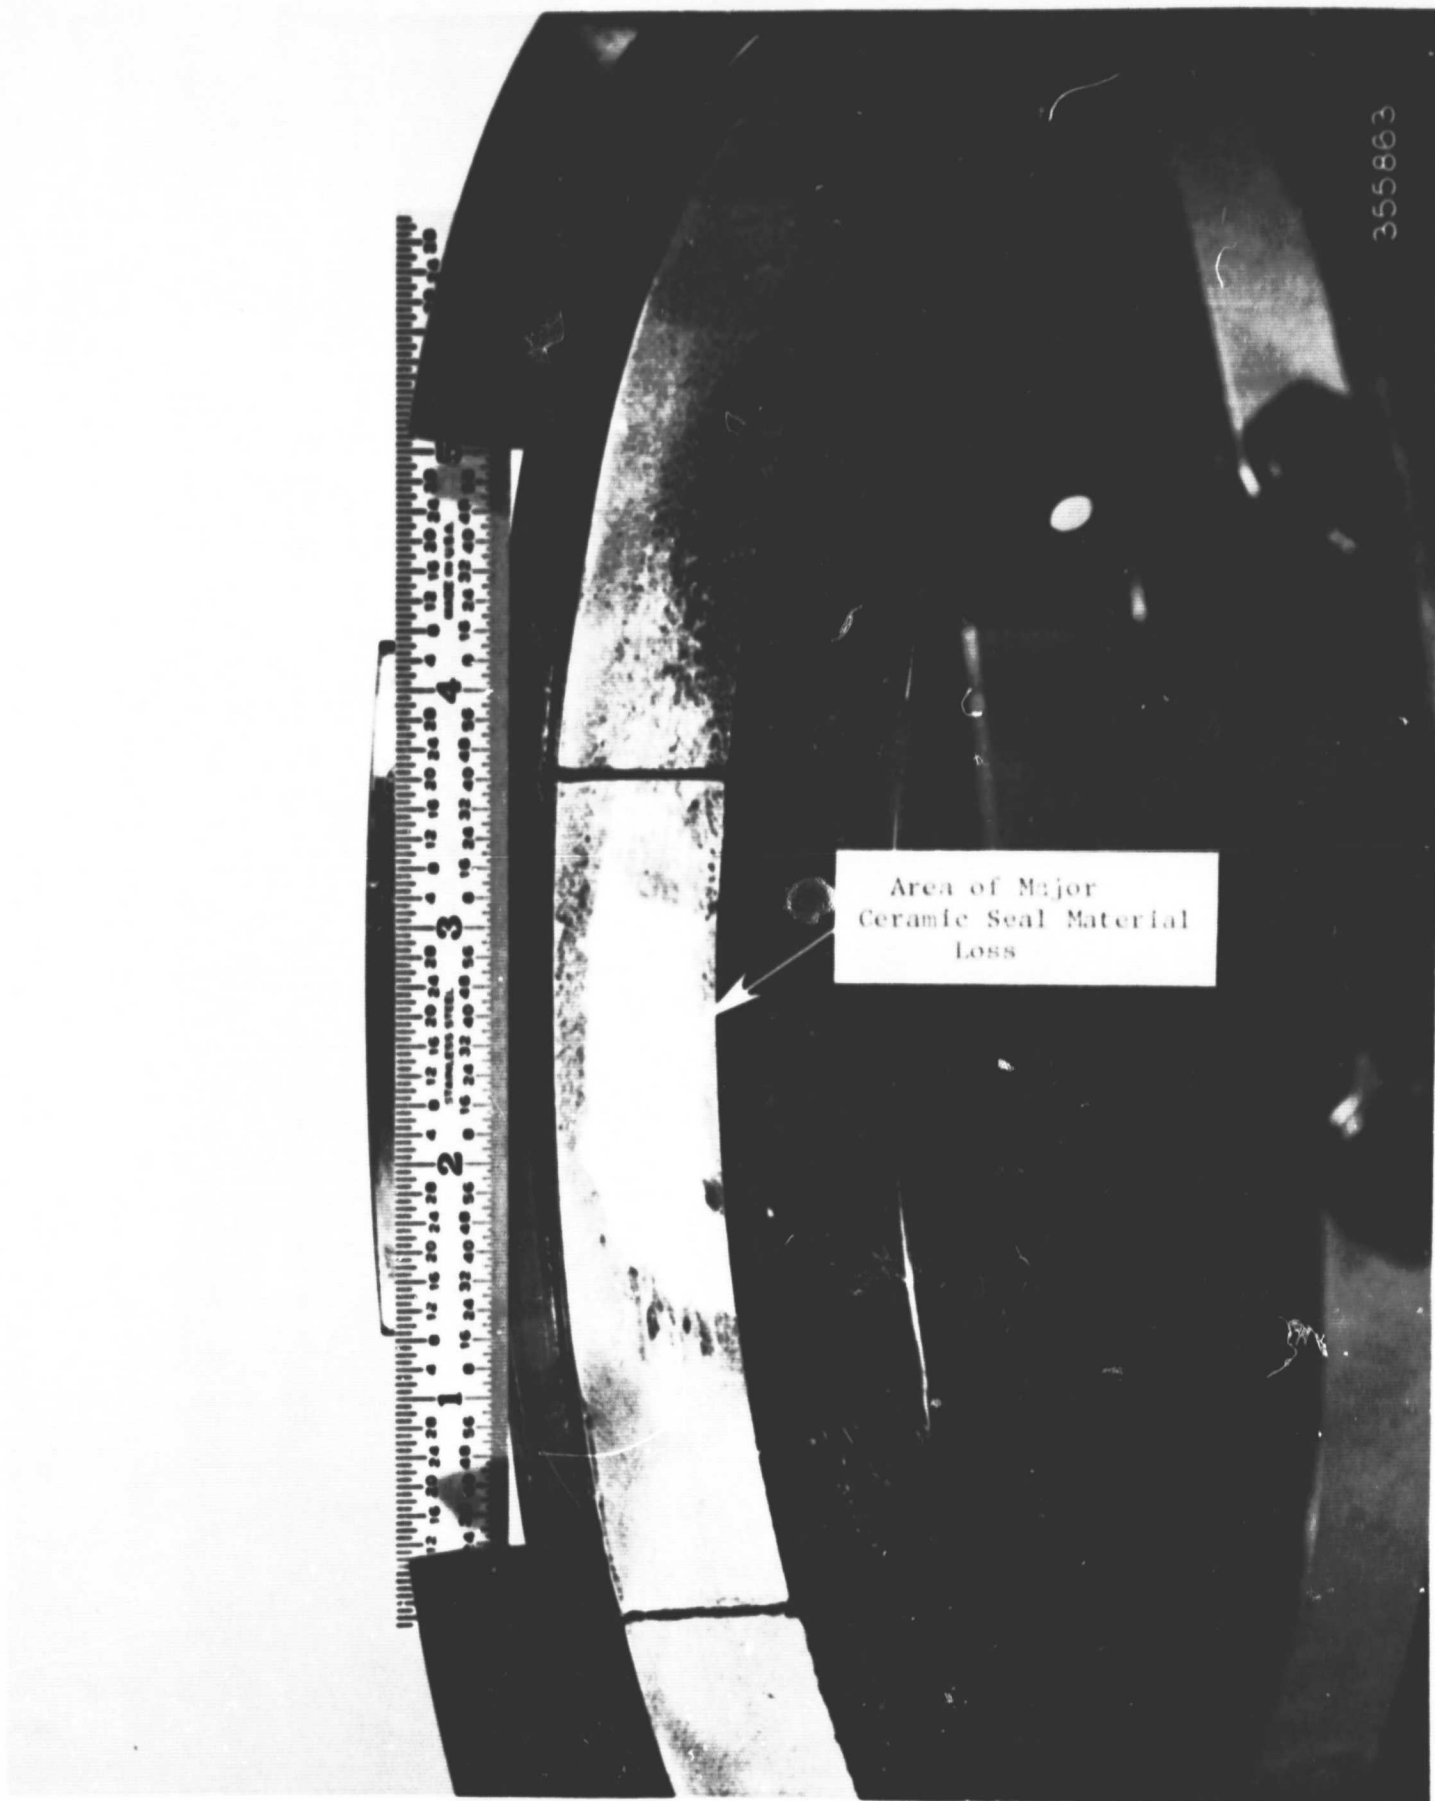
Figure 61 Material removed from GMA 500/ATDE first-stage turbine tip seal following heavy rub during first minute of operation.

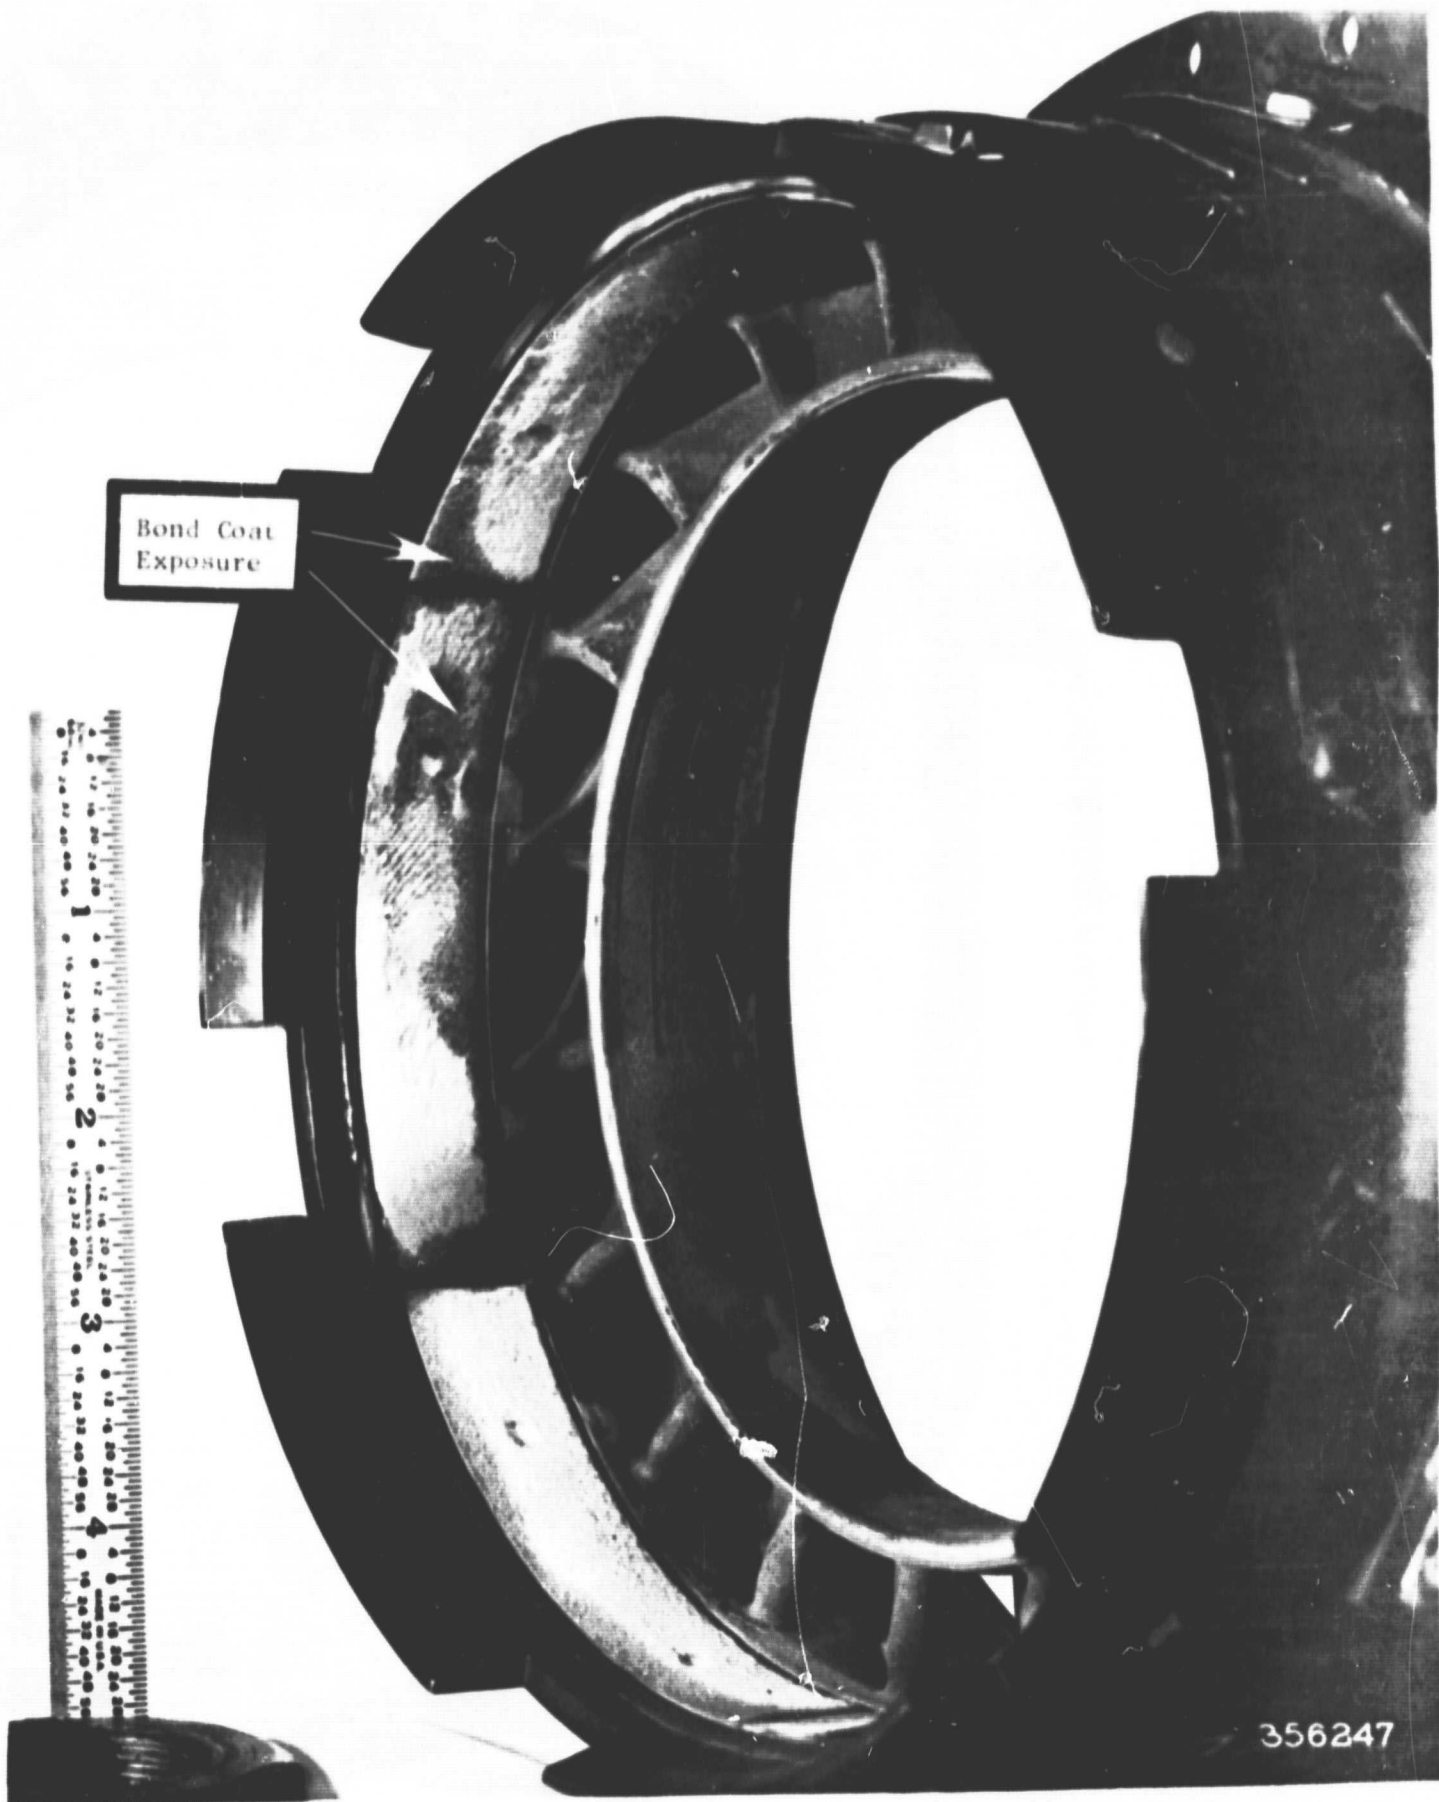
Figure 62 Condition of GMA 500/ATDE first-stage turbine tip seal following 68:13 hours total test time.

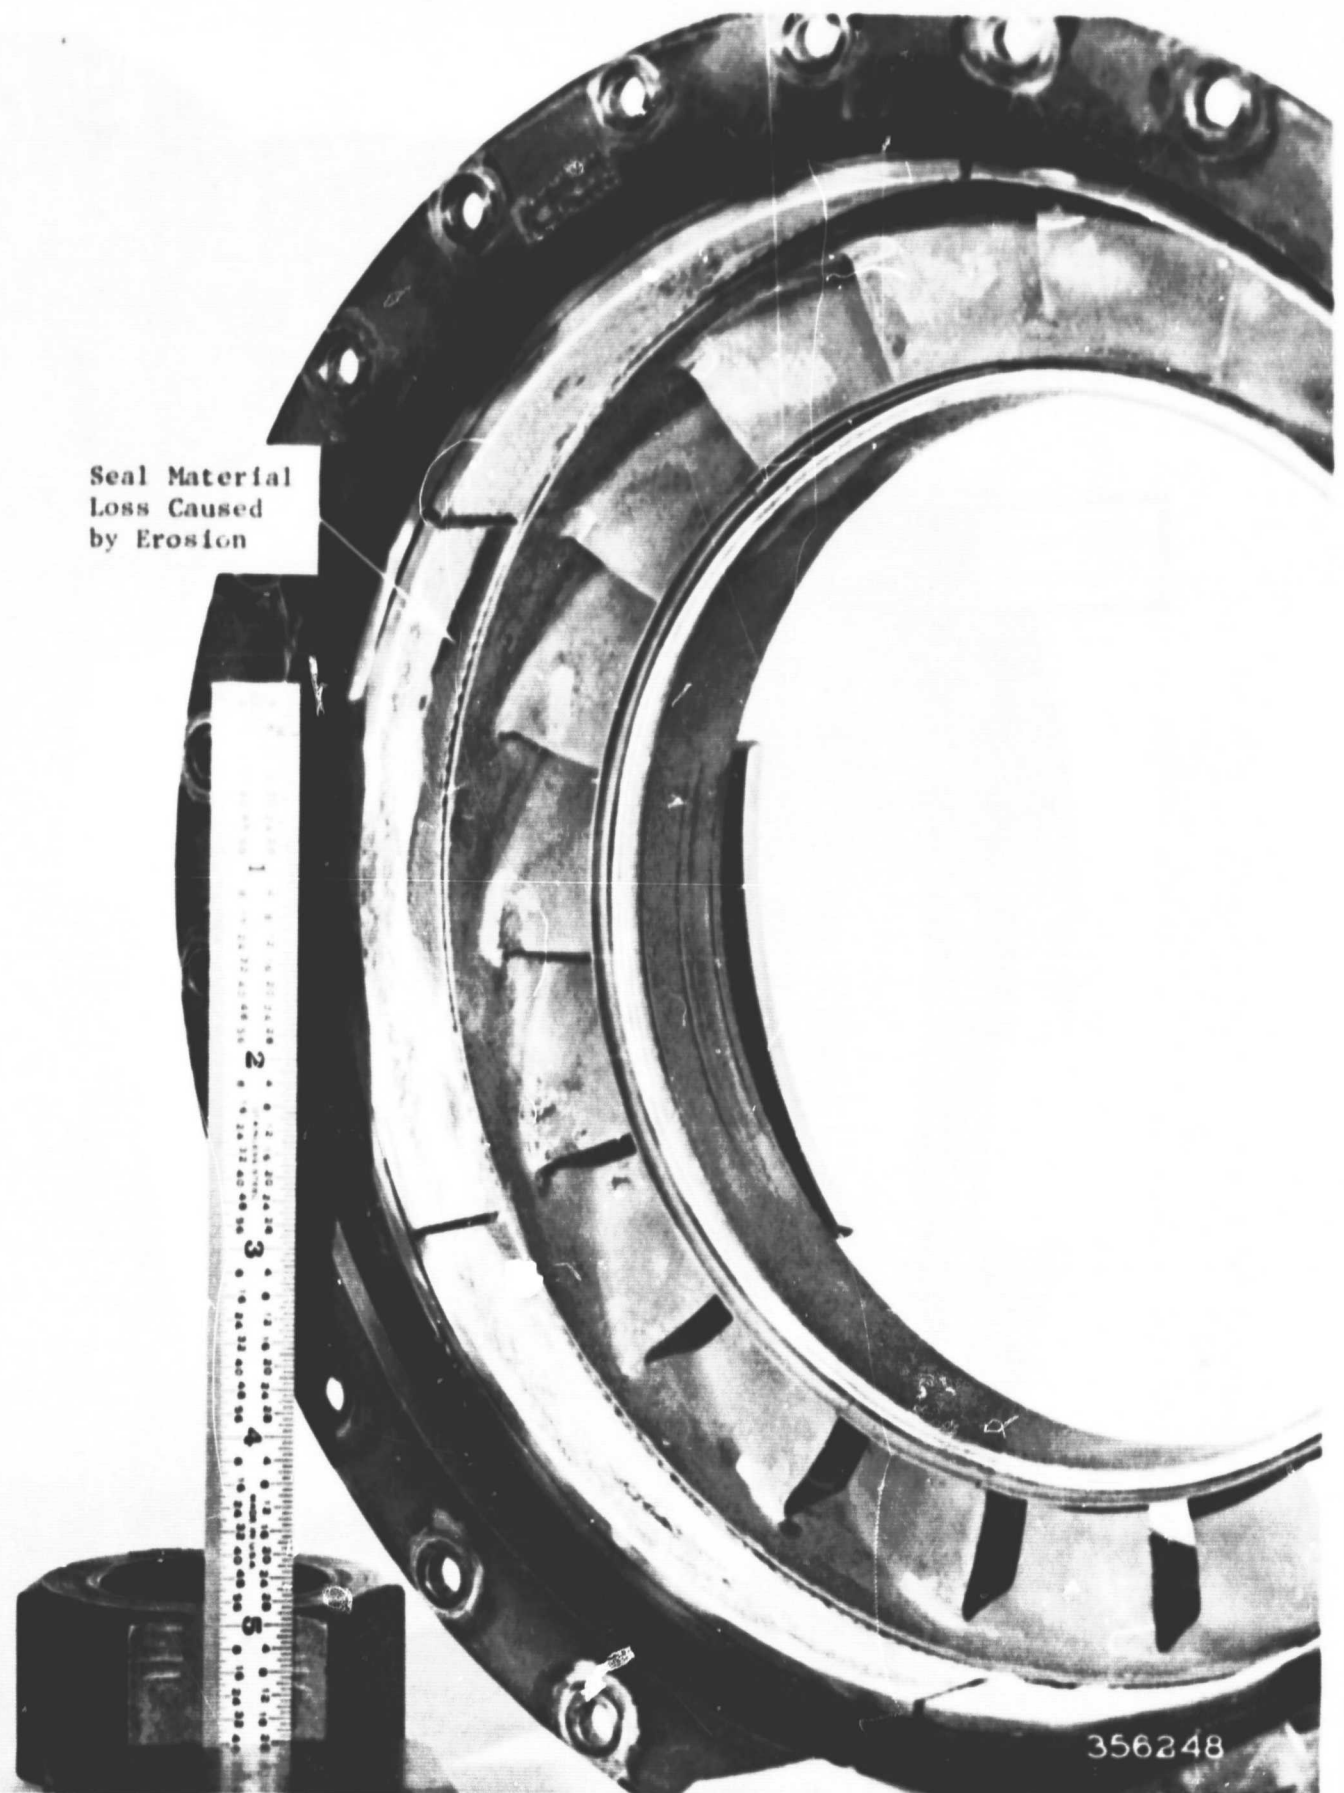
Figure 63 Condition of GMA 500/ATDE second-stage turbine tip seal following 68:13 hours total test time.

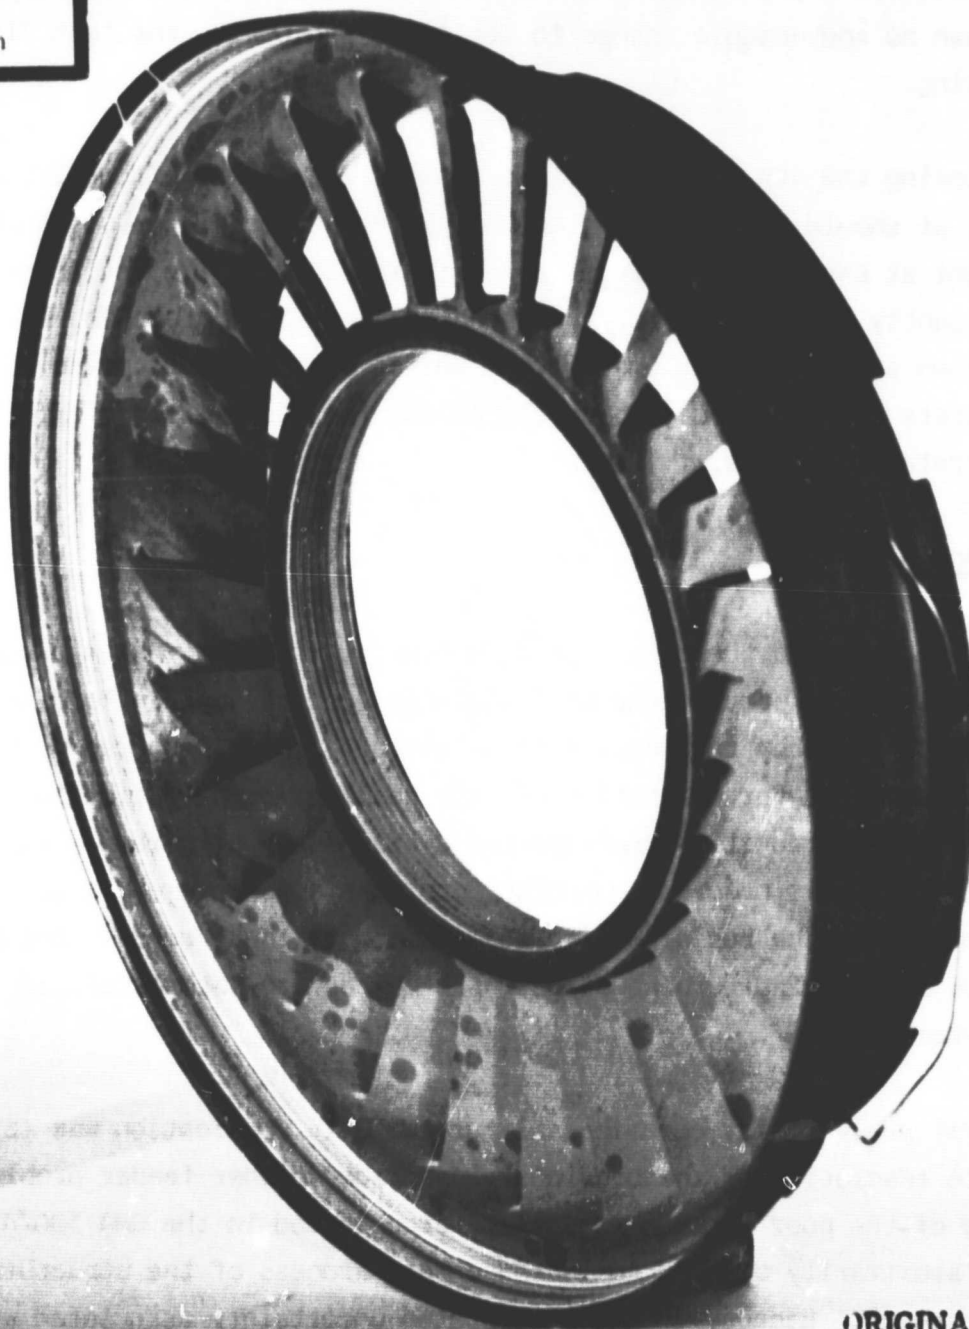
The condition of the seal installed in the 4th stage turbine seal location following 35:29 hours of testing is shown in Figure 64. It can be seen from this photograph that the knives on the shroud have rubbed the seal over the entire circumference. Some slight evidence of erosion at the aft edge of the seal is also present.

Figure 64 Condition of GMA 500/ATDE fourth-stage turbine tip seal following 35:29 hours total test time.

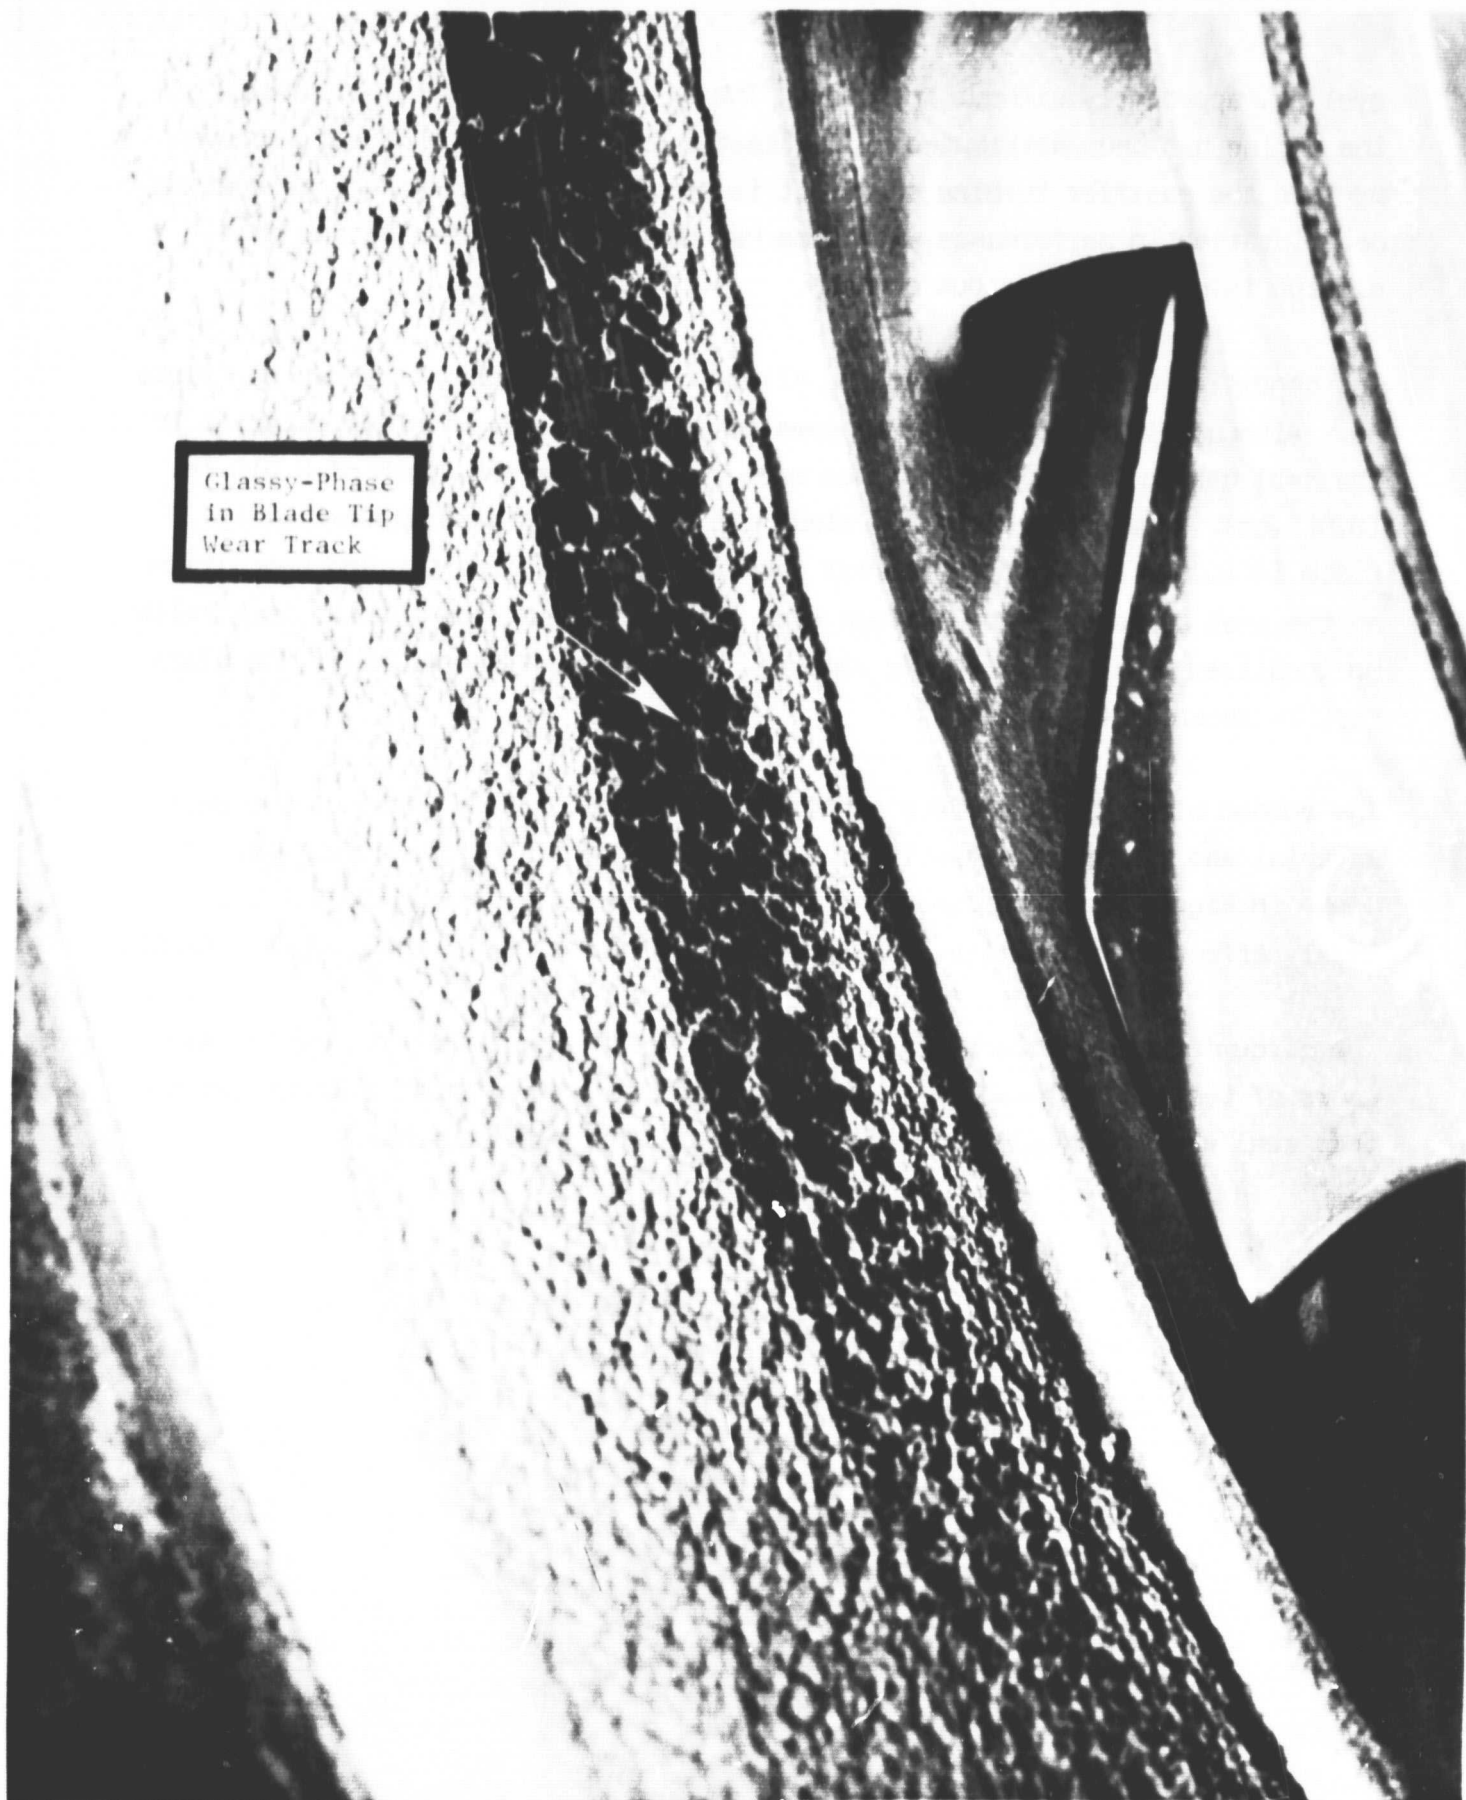
Figure 66 Condition of successful CATE gasifier turbine seal following 41:00+ hours total test time.

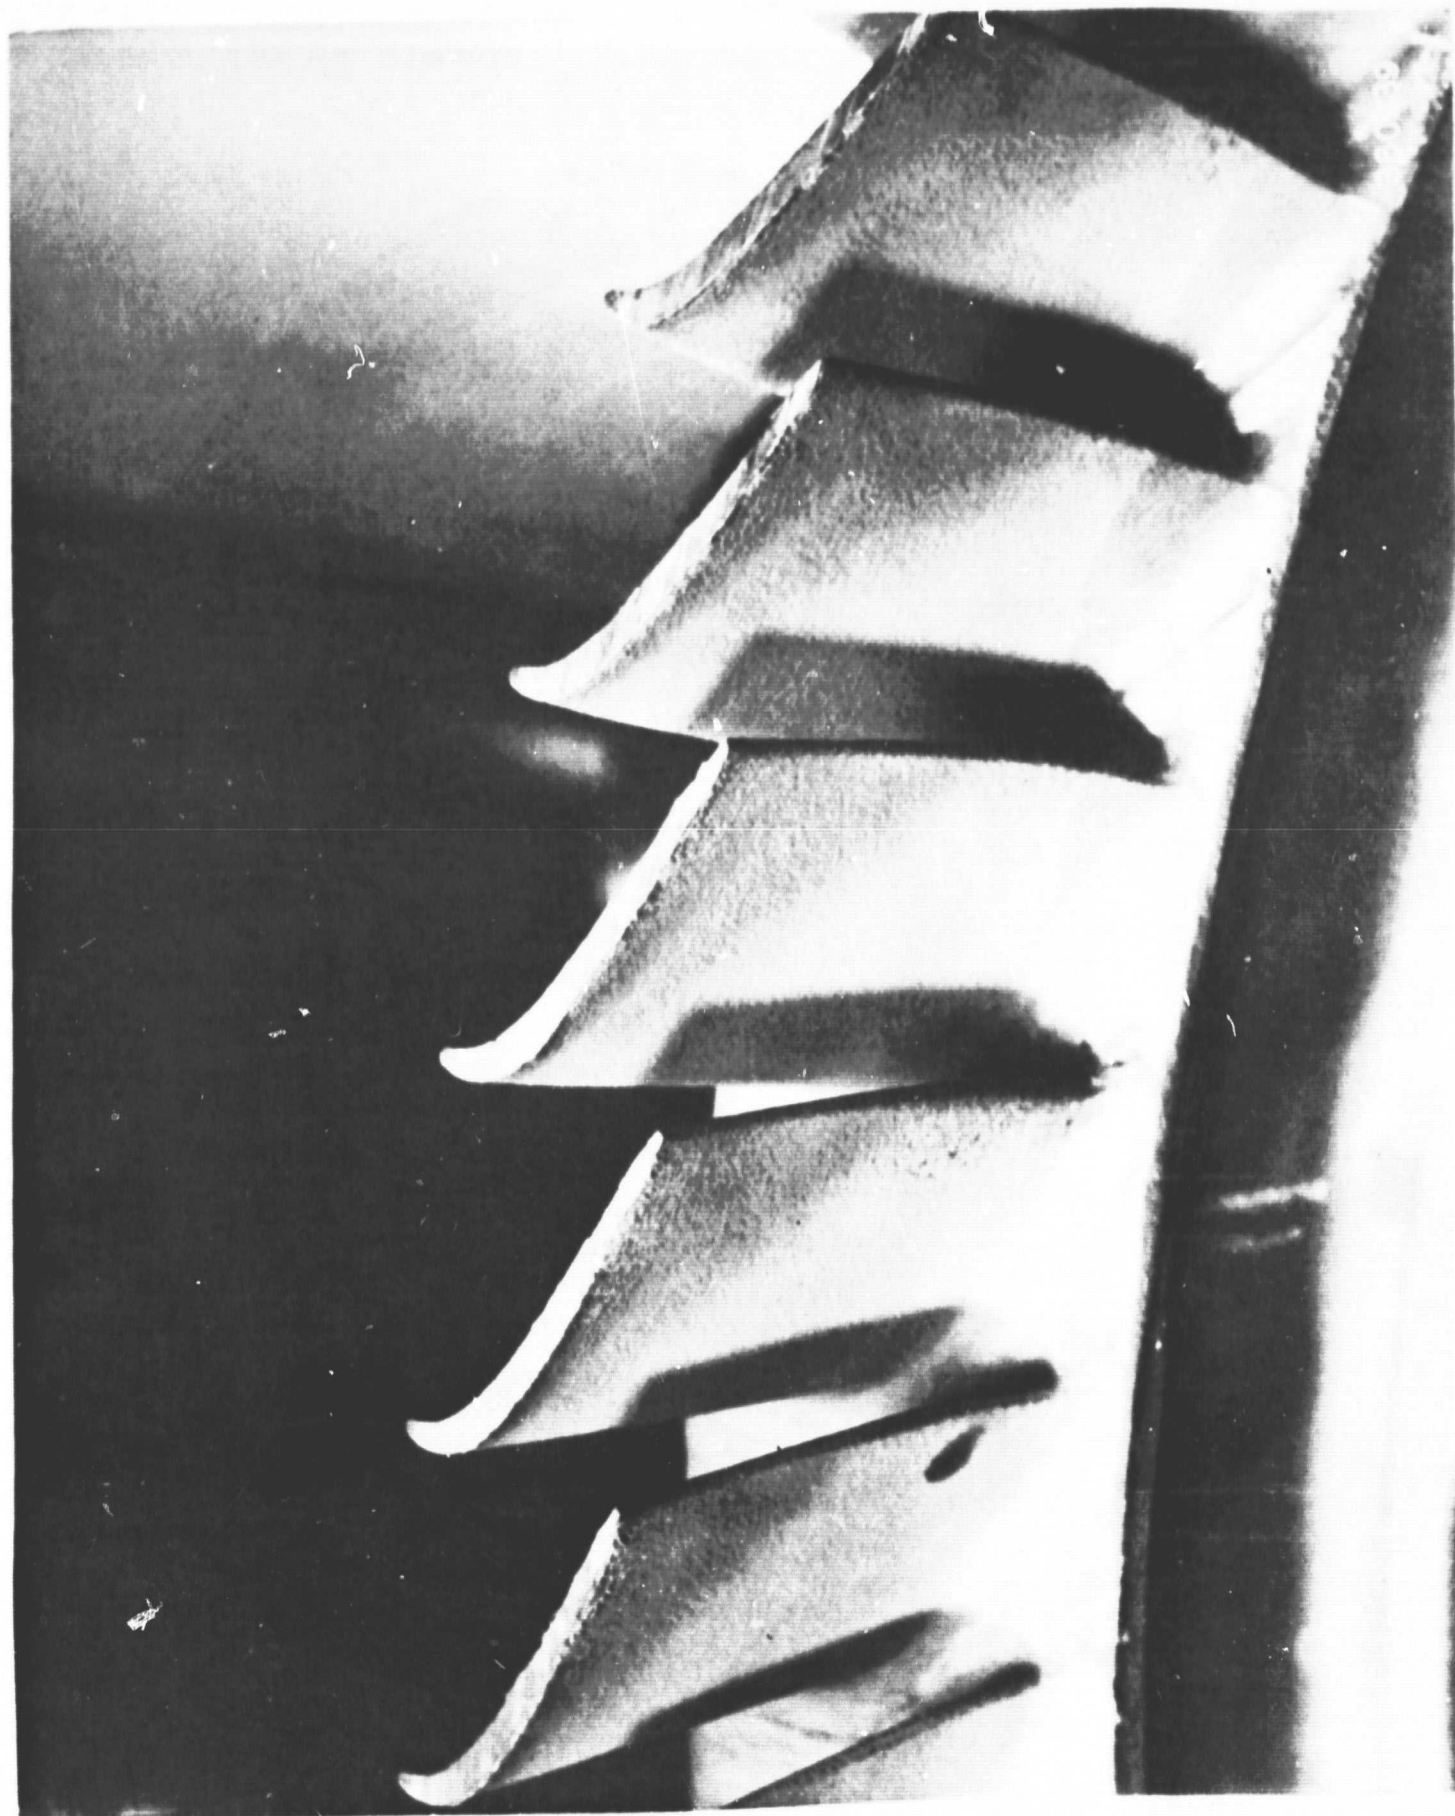
Figure 67 Condition of CATE gasifier turbine blades following 41:00+ hours total test time.

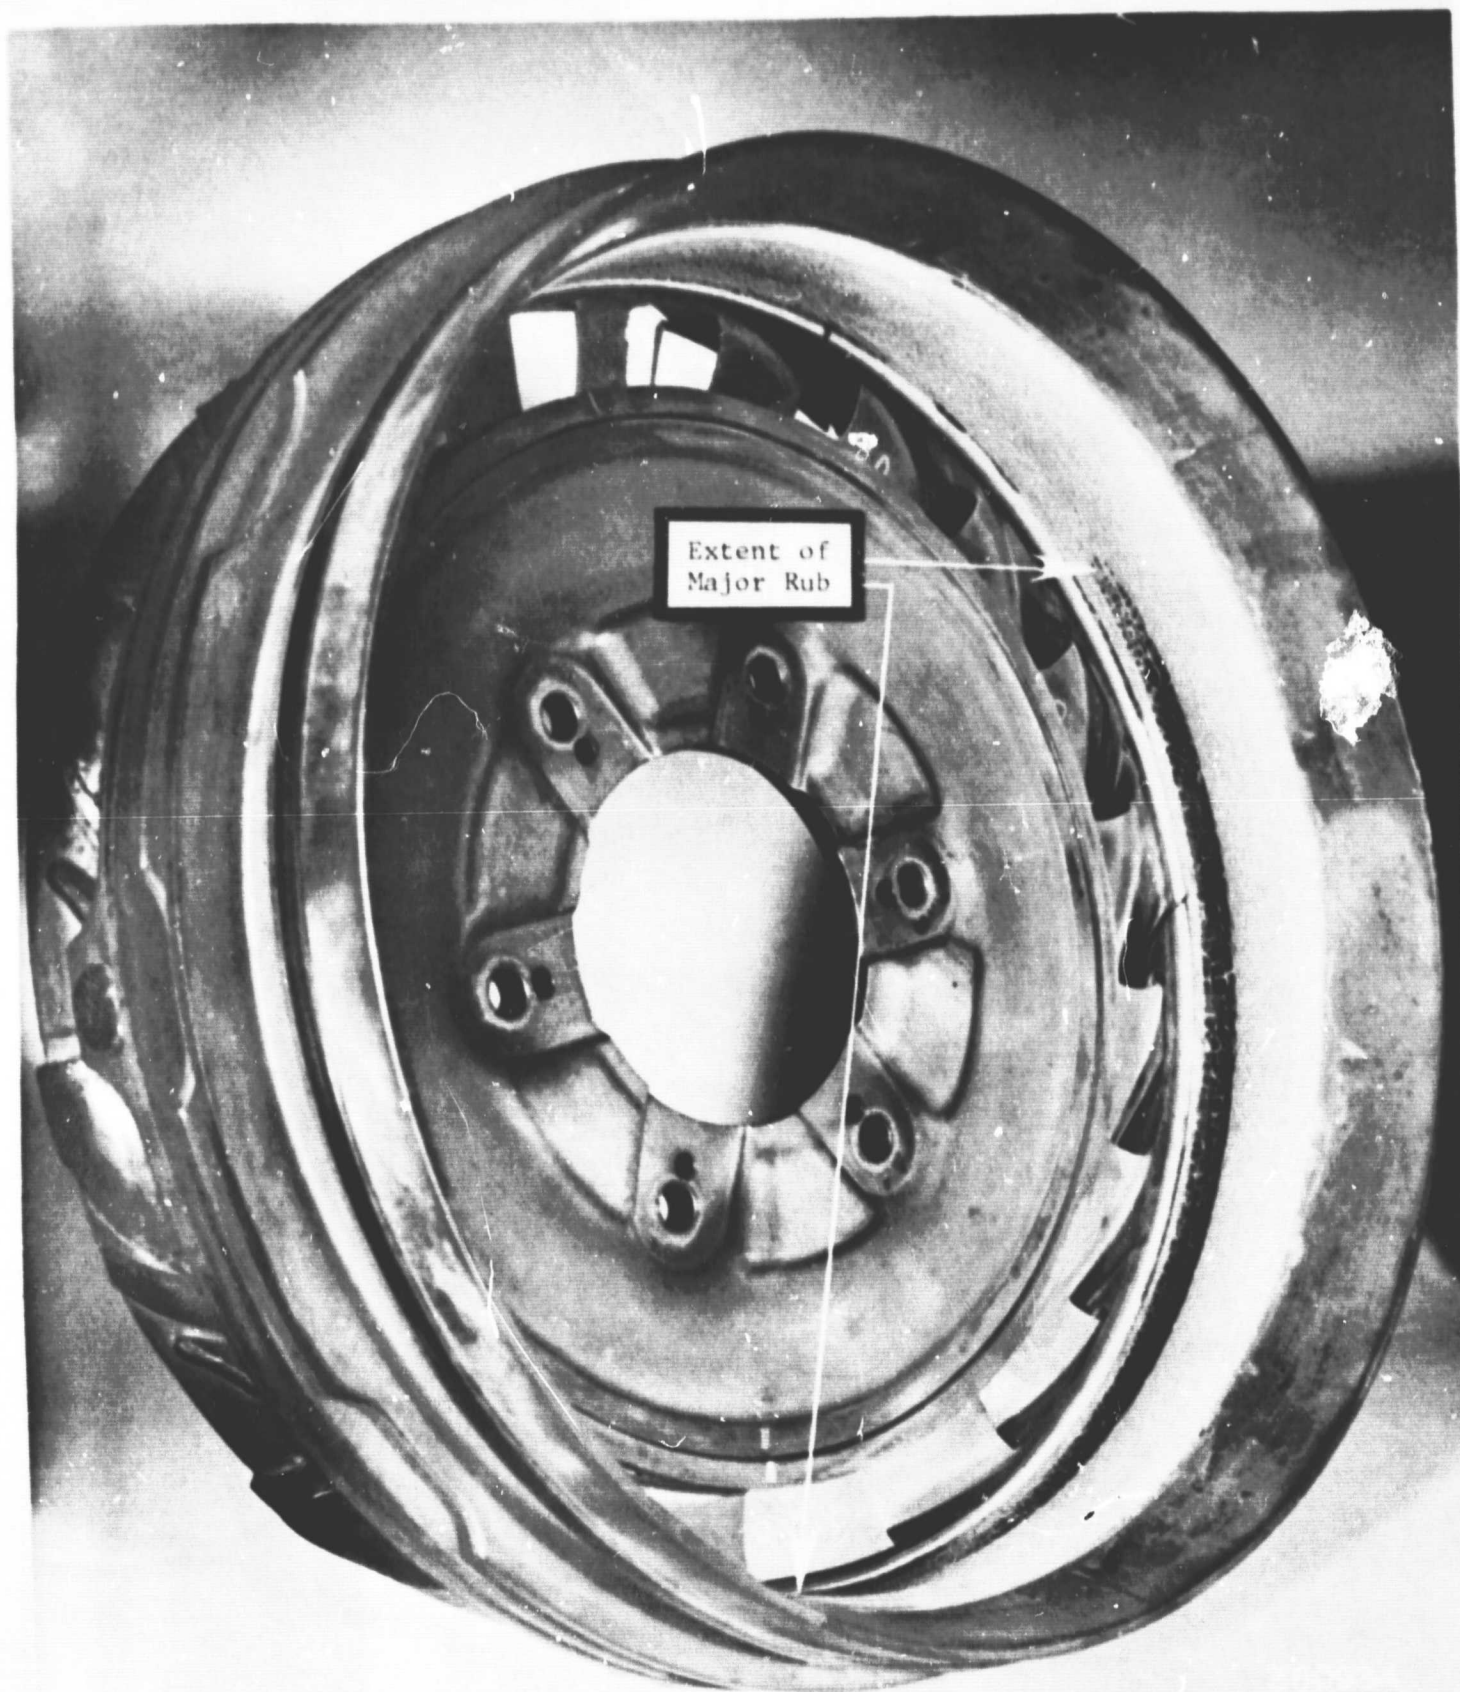
The circumferential extent of the rub interaction experienced during the 41+ hours of testing is shown in Figure 68. Following photographic documentation this seal was re-installed in the engine for additional service.

Figure 68 Circumferential extent of rub interaction experienced during 41:00+ hours total test time.
